REPORT OF INVESTIGATION

Fatal Electrical Accident
March 23, 2003

No. 50 Mine
Energy Plus, Inc.
Kimball, McDowell County, West Virginia
I.D. No. 46-08776

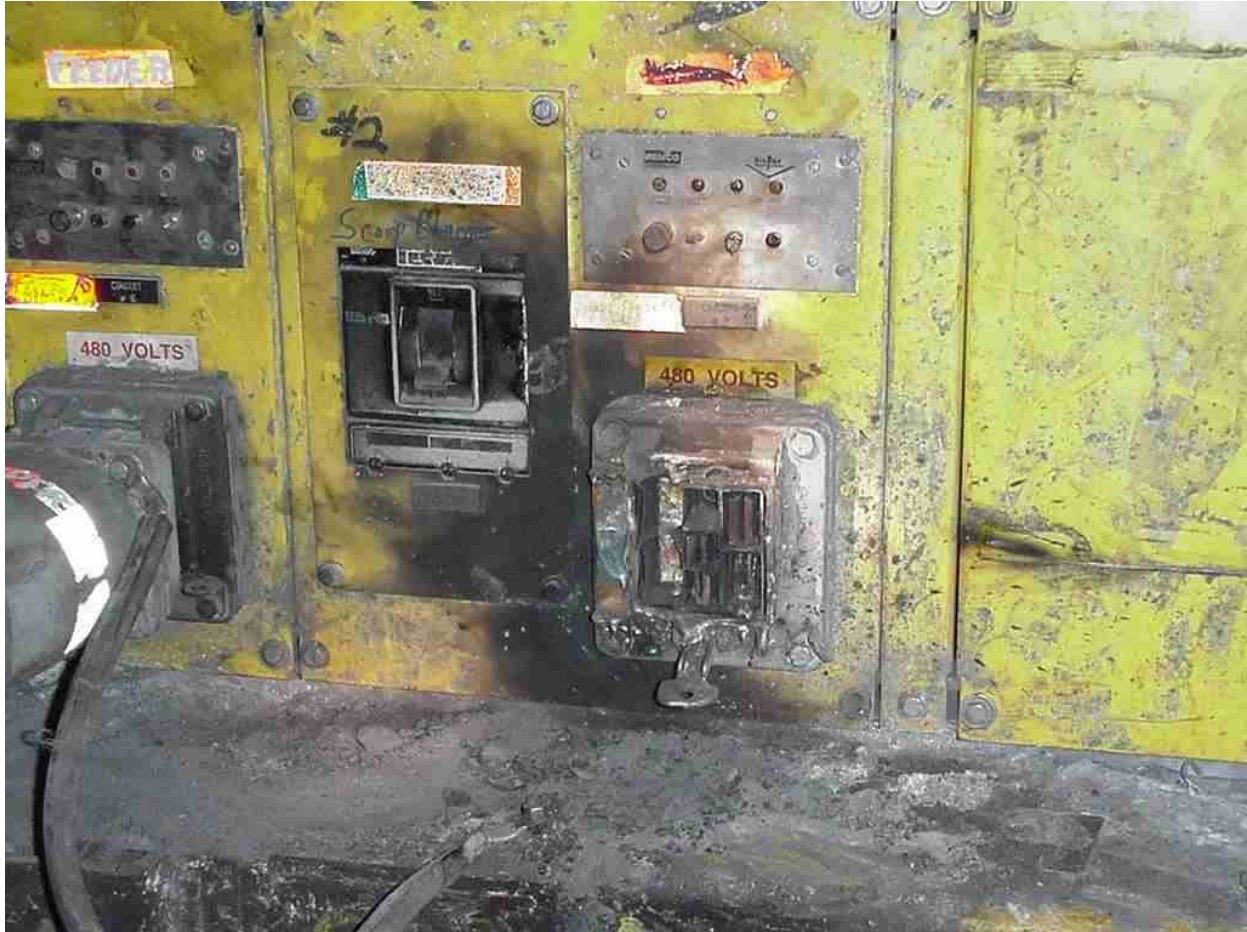
Photograph of the 480-volt receptacle located on a section power center used to detonate explosives during the accident.

3. Causal factor: The Model VME 450 Blasting Machine, Serial Number 4774, obtained from the mine, is not on the approved list of permissible blasting machines. The 480-volt ac, 3-phase, resistance grounded, 225 amp receptacle on the section power center, utilized to detonate explosives, is not a permissible blasting machine.

It is the consensus of the investigation team that the direct cause of the fatal accident was the victim's use of 2-phases of an energized 480-volt, resistance-grounded, 225 amp circuit on the section power center to detonate explosives. This resulted in an electrical arc that produced intense heat. Williams, being in the immediate area of the arcing fault, received burns that resulted in his death on April, 10, 2003.

Corrective Action: Only approved blasting machines of adequate size for the number of shots shall be utilized in underground coal mines for blasting.
